RE: June Monthly Report  
1.5 Mile Reach Removal Action  
GE-Pittsfield/Housatonic River Site

**Figure 1**  
**1.5 Mile Removal Action**  
**Site Map (Map 1 of 2)**  
**June 2006 Monthly Report**

**Figure 1  
1.5 Mile Removal Action  
Site Map (Map 2 of 2)  
June 2006 Monthly Report**

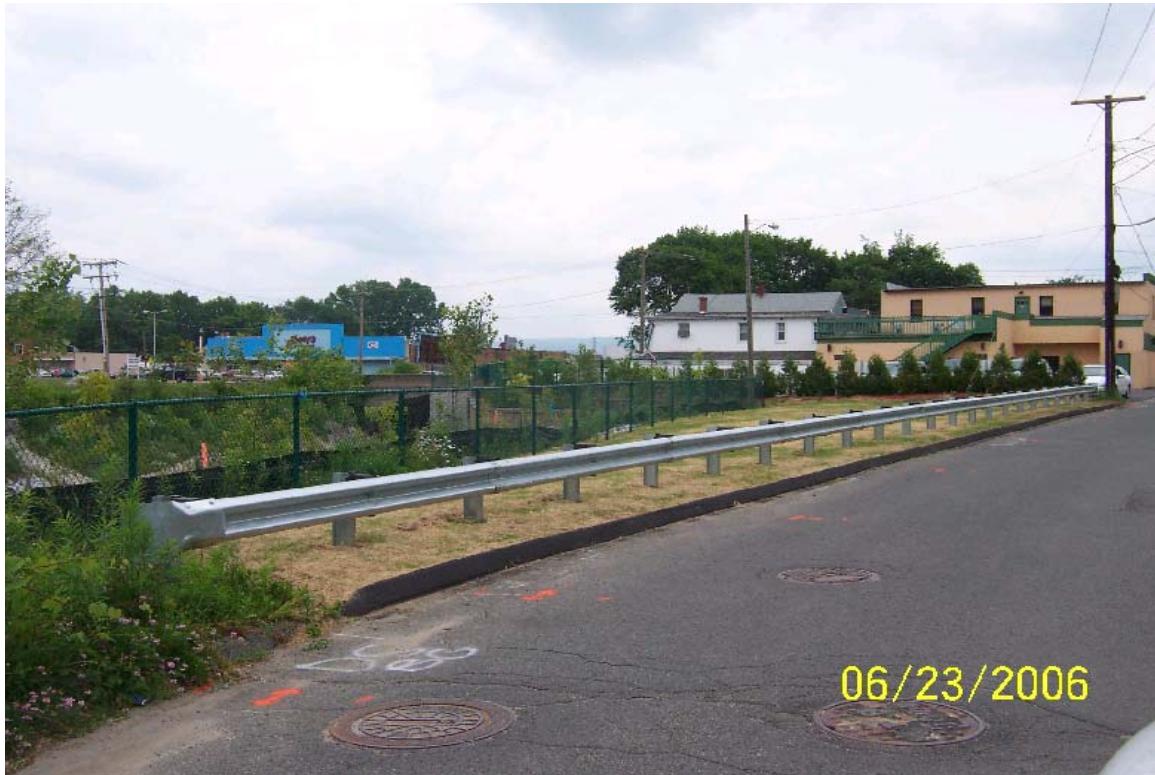
**Photograph 1 – Overview of Restored Parcels I8-10-2 and I8-10-3**

By the end of May, activities associated with the restoration of Parcels I8-10-2 and I8-10-3 were initiated. First, the parking curbs were removed from the temporary parking lot on Parcel I8-10-3, then the parking lot was re-graded. Next, the temporary site security fence was removed. During the month of June, the restoration of Parcels I8-10-2 and I8-10-3 was completed. A new permanent fence was installed along the riverbank of the two parcels. Installation and grading of topsoil was completed, asphalt curbing was then installed and the area was seeded. Lastly guard railing was installed.

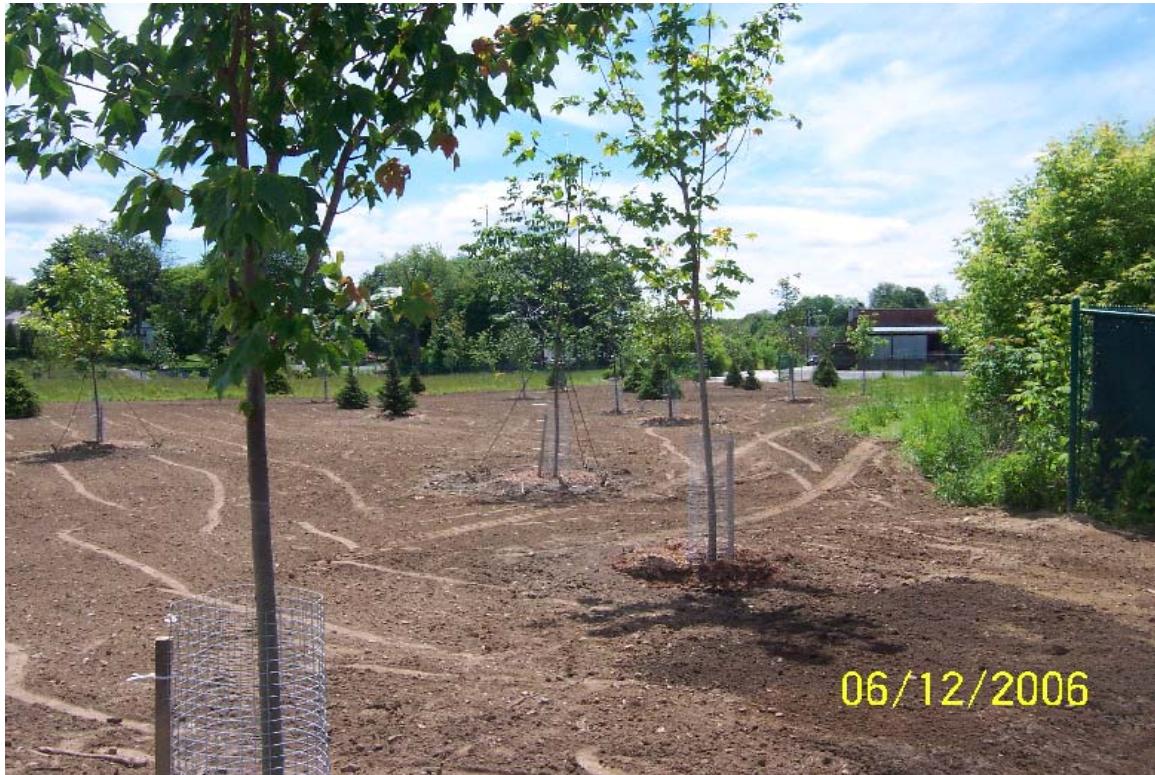
**Photograph 2 – Restoration Activities on Parcel I8-24-1, Area York-Raked and Prepared for Hydro-seeding**

Also, by the end of May, the restoration activities on Parcel I8-24-1 were initiated. The topsoil was installed in the areas where the access road/staging area was removed and planting of the 75 large trees within the parcel was then completed. During the month of June, the restoration of Parcel I8-24-1 continued. The area where the topsoil was installed was york-raked and hydro-seeded. New permanent fencing was installed around the property. Activities associated with re-paving of the parking lot and the installation of a new sidewalk and a granite curb were completed. Pea stone was installed around the newly paved parking lot areas. Material generated during the restoration of the parking lot was transported to the Area 64D north staging area. The striping of the parking lot will be done at a later date.

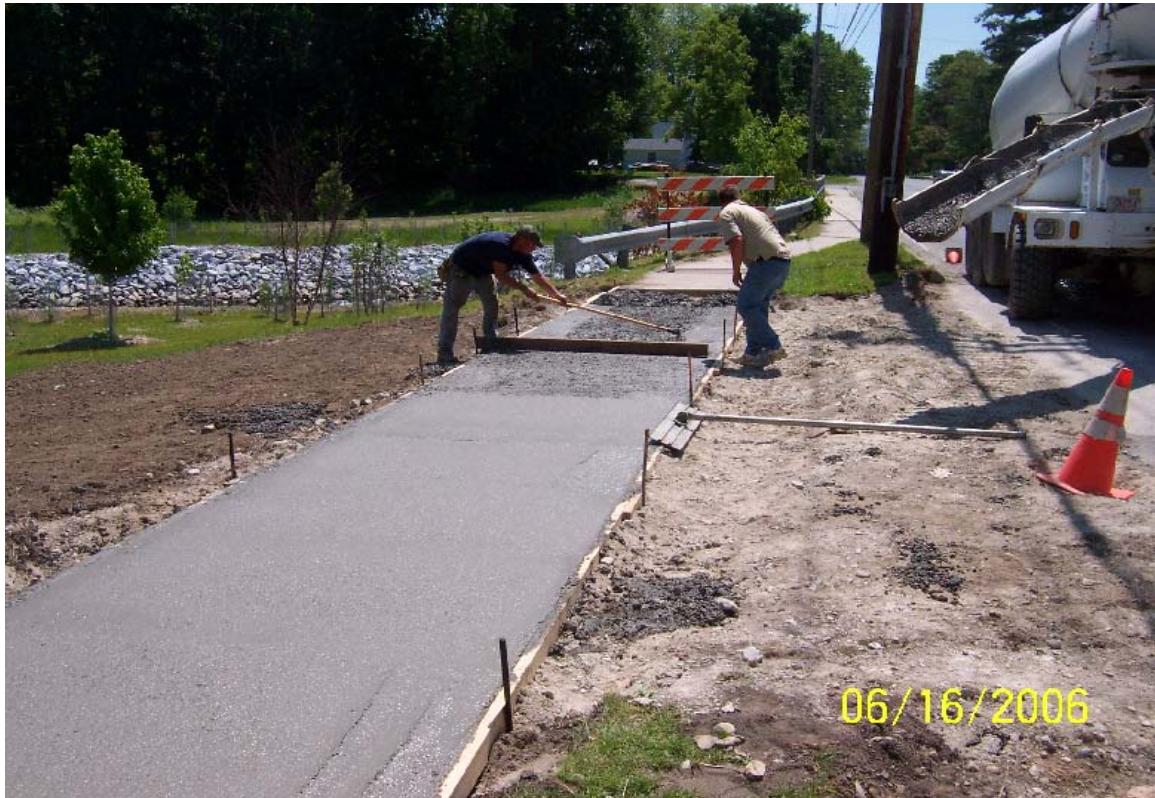
**Photograph 3 – Installation of the Sidewalk on Parcel I7-2-1**

Final restoration activities on Parcel I7-2-1 were initiated. First, the temporary site security fence was removed. Next, the final grading of the areas that were utilized as an access road was completed and topsoil was placed to return the area to its pre-construction grade. Then, the sidewalk was installed. Lastly, the areas were seeded and covered with biodegradable coconut mats. The concrete curbing will be installed at a later date.

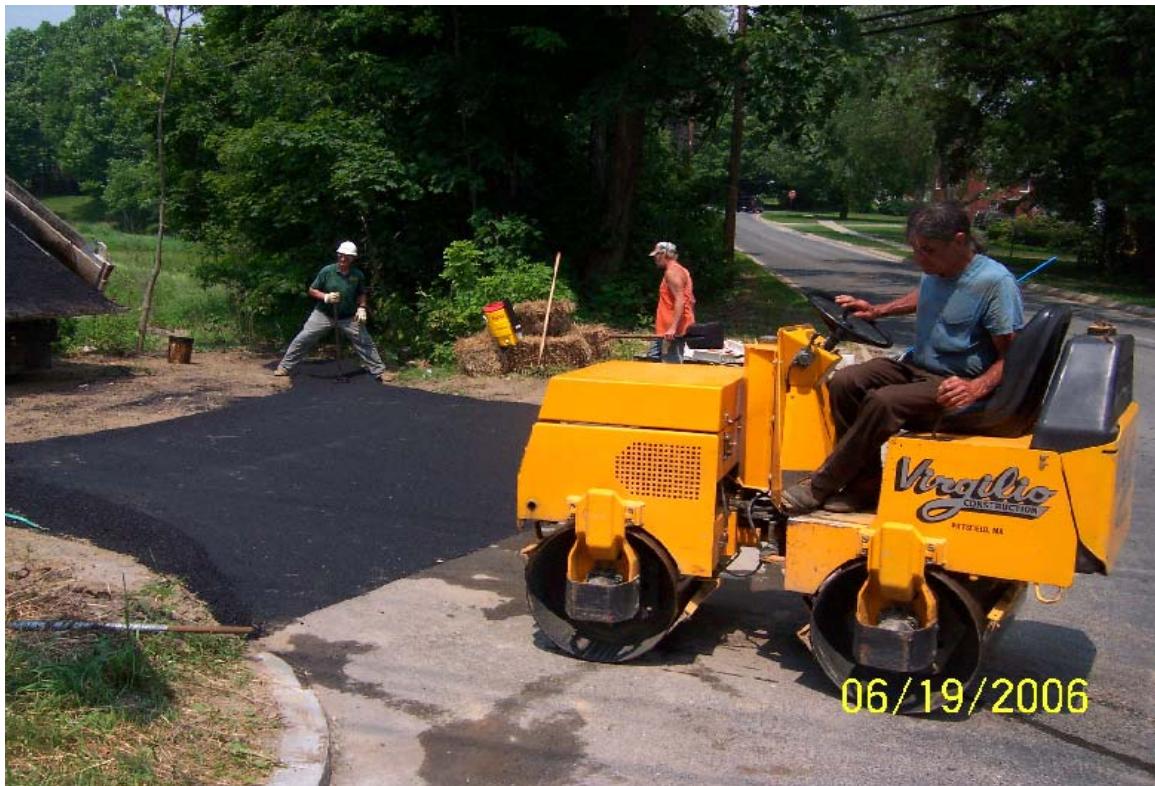
**Photograph 4 – Restoration Activities on Parcel I7-3-1**

Restoration activities on Parcel I7-3-1 were completed. First, the damaged sidewalk and the curb at the entrance to the parcel located on the corner of Pomeroy Avenue and High Street was removed. The areas that were utilized as access road were then re-graded and topsoil was placed to return the area to its pre-construction grade. The area where the topsoil was placed was seeded and biodegradable coconut mats were installed. Next, the entrance area was repaved and the asphalt curbing was repaired. Fencing was then installed around the entrance area.

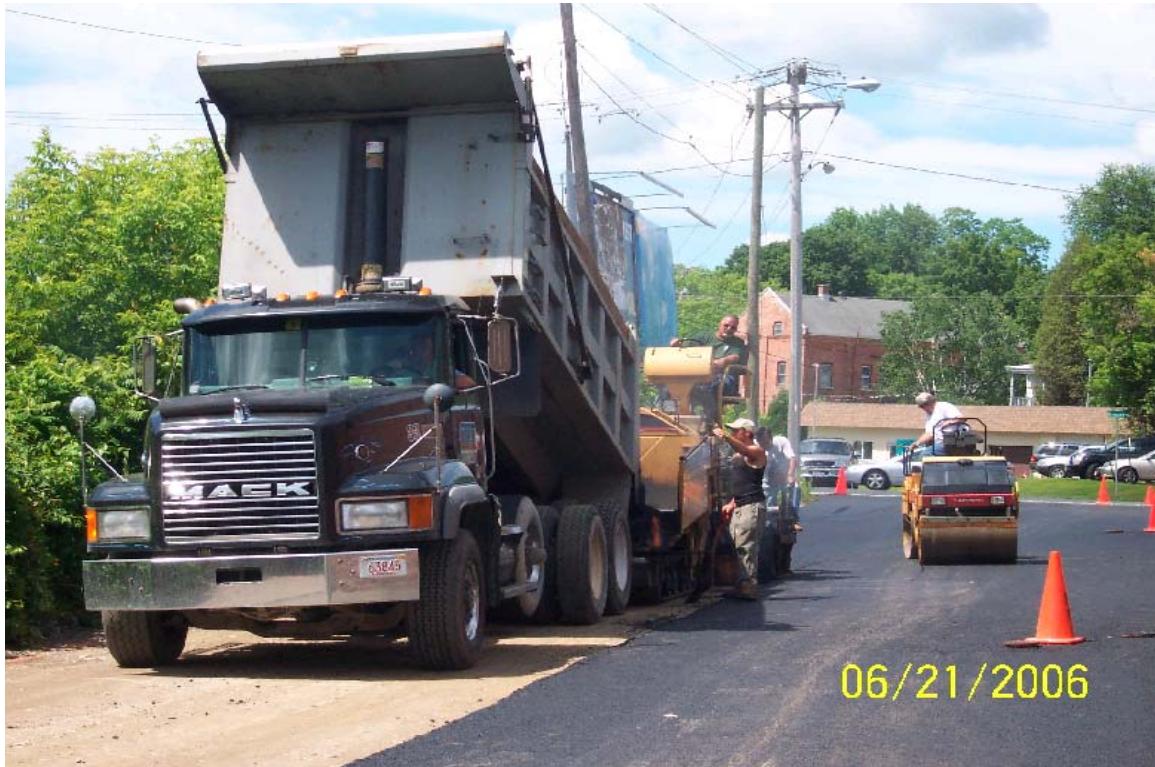
**Photograph 5 – Restoration Activities on Parcel I8-24-1**

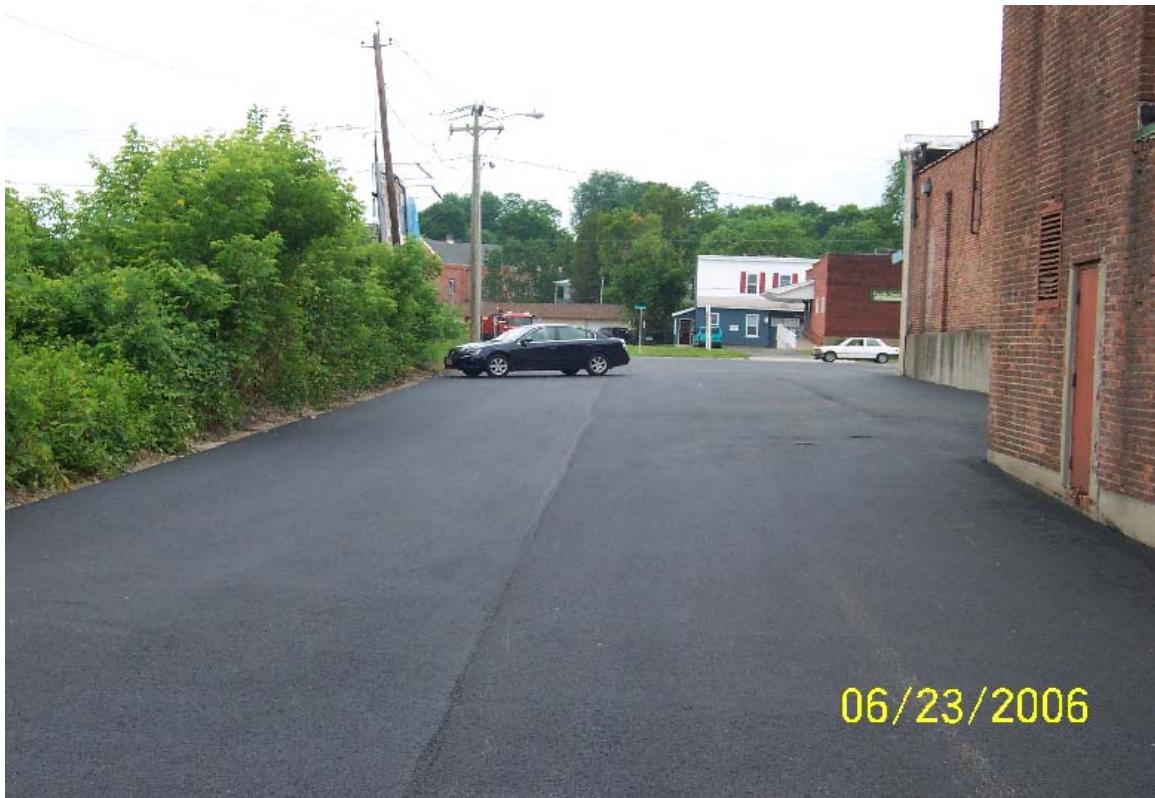
**Photograph 6 - Overview of Completed Paving on Parcel I8-24-1**

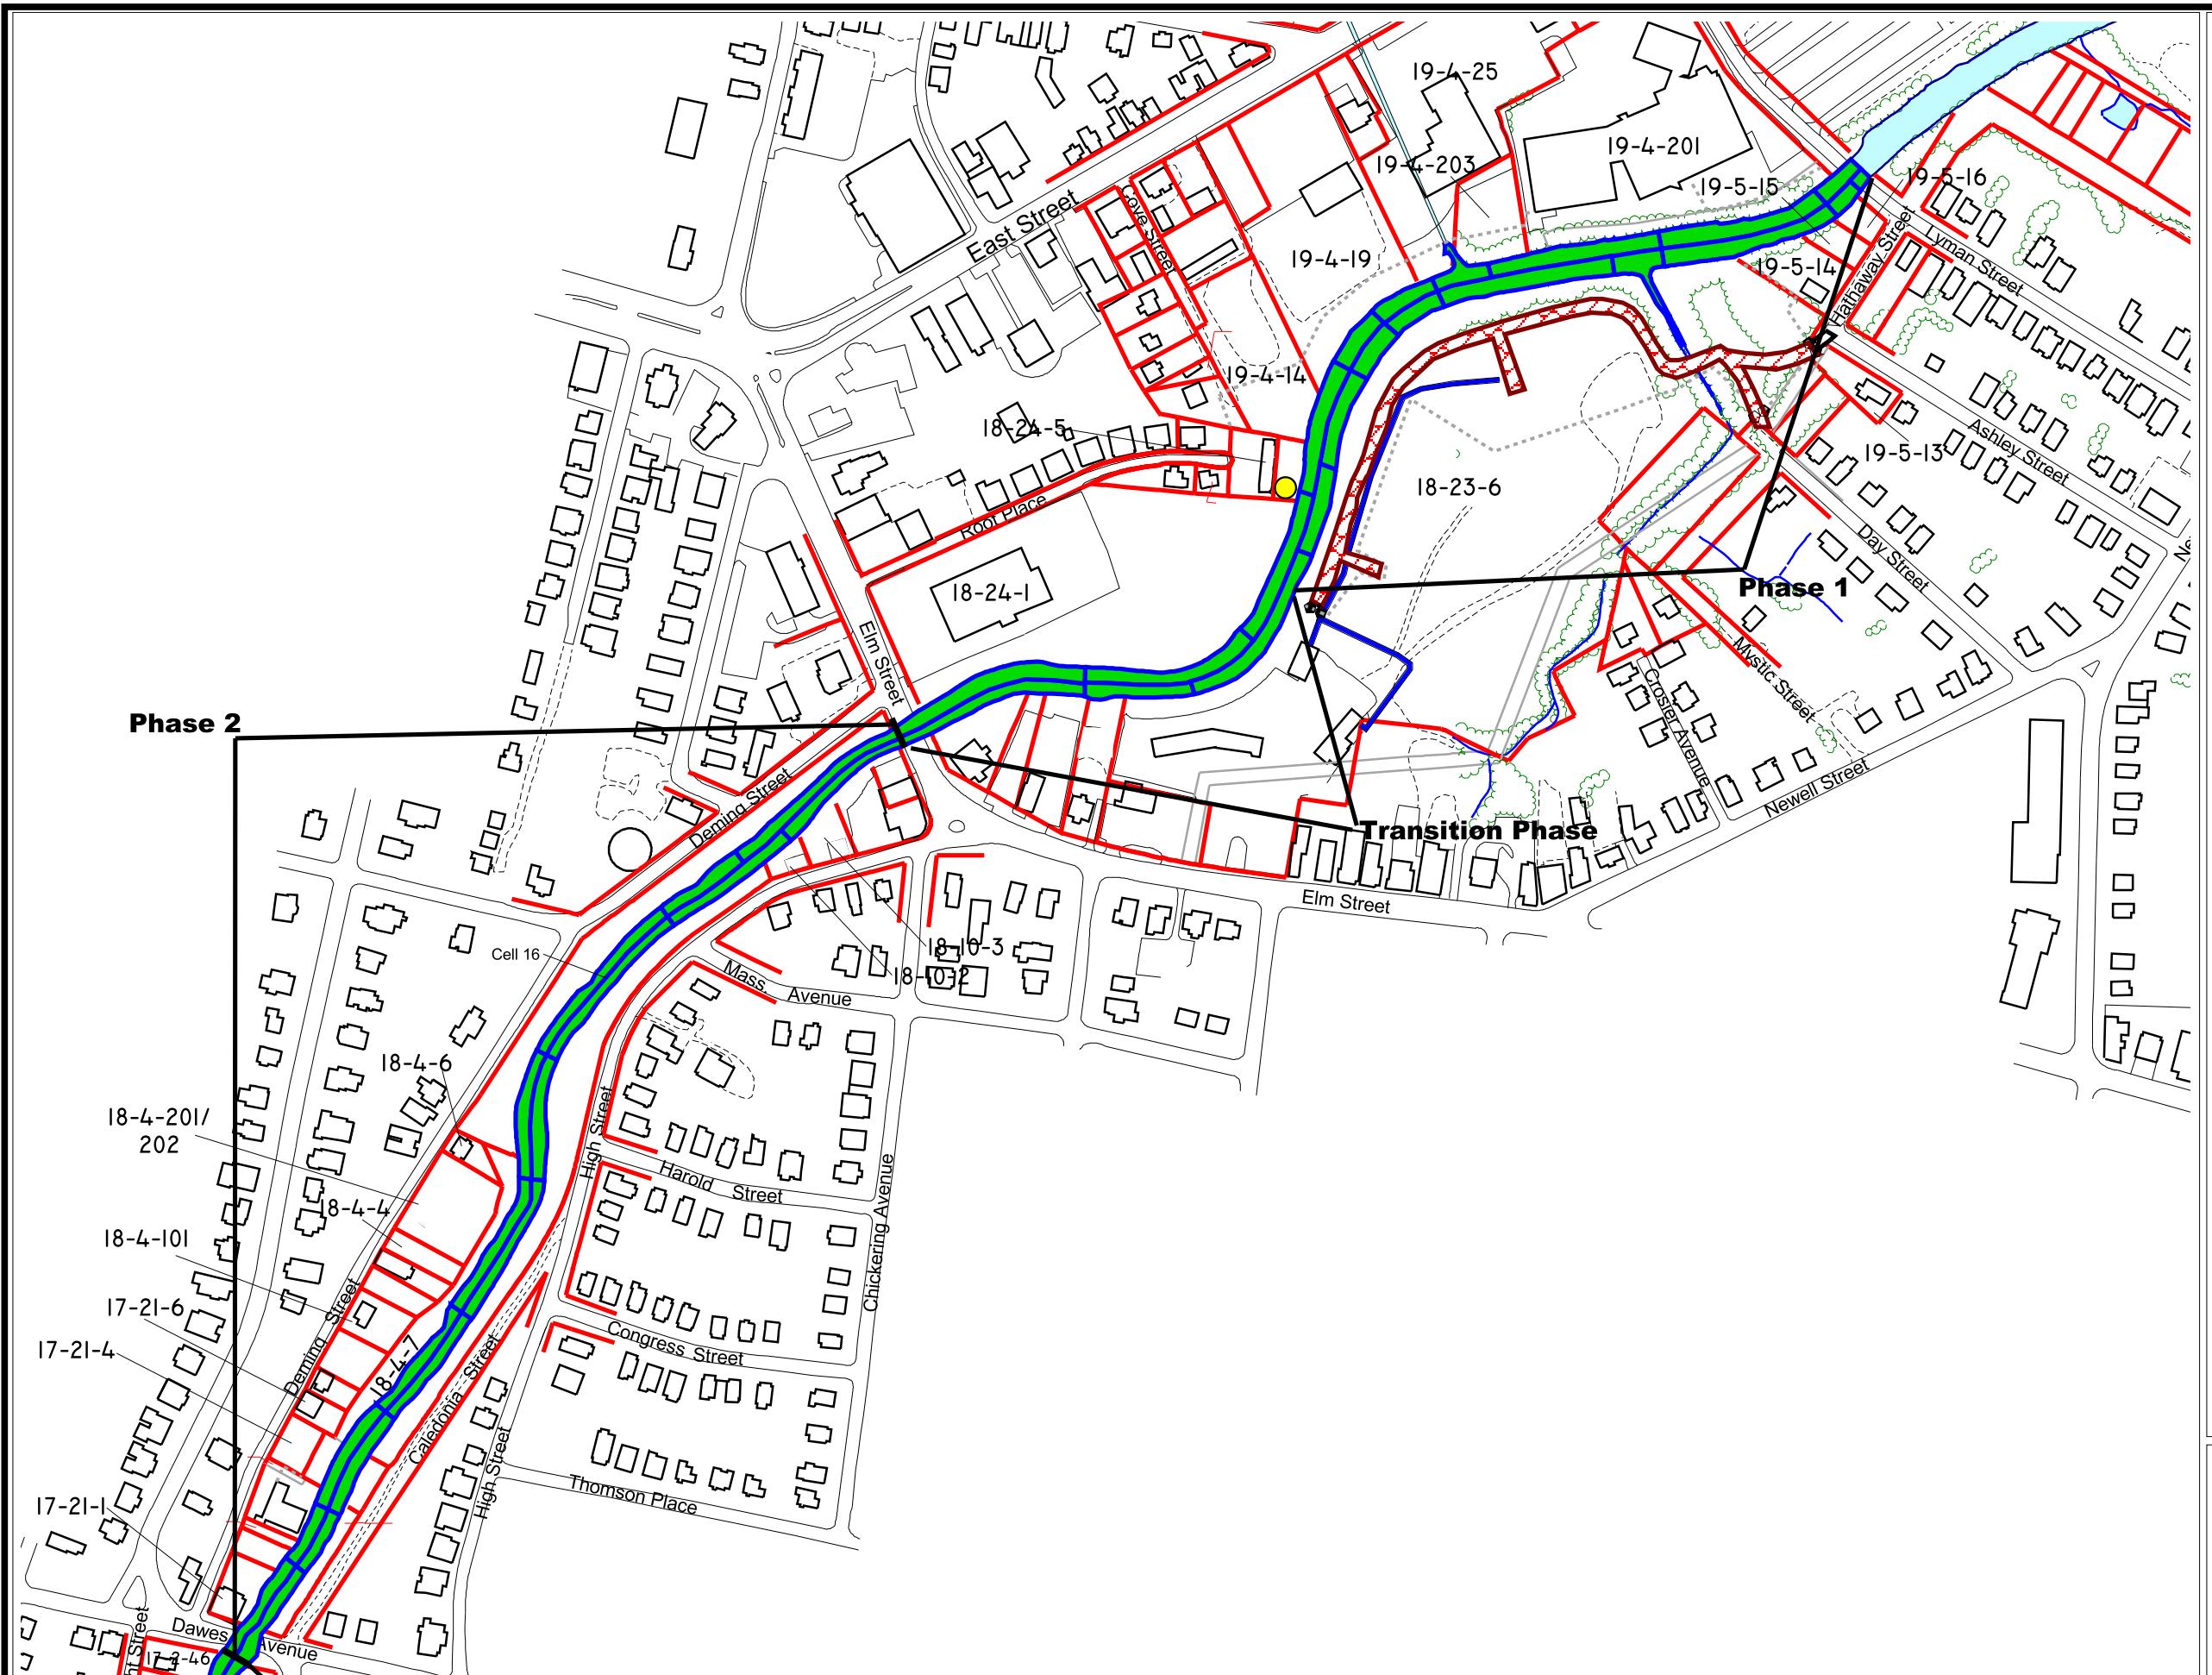
Figure 1 (2 maps) includes the layout of all excavation cells, vibration monitoring locations, access road locations, excavation load-out locations, staging area locations, fence line location, the water treatment system pad locations and the floating river barge crossing.
